1 September 2009

Draft Executive Summary

Conditions Assessment and Recommendations Chavis Park Carousel House

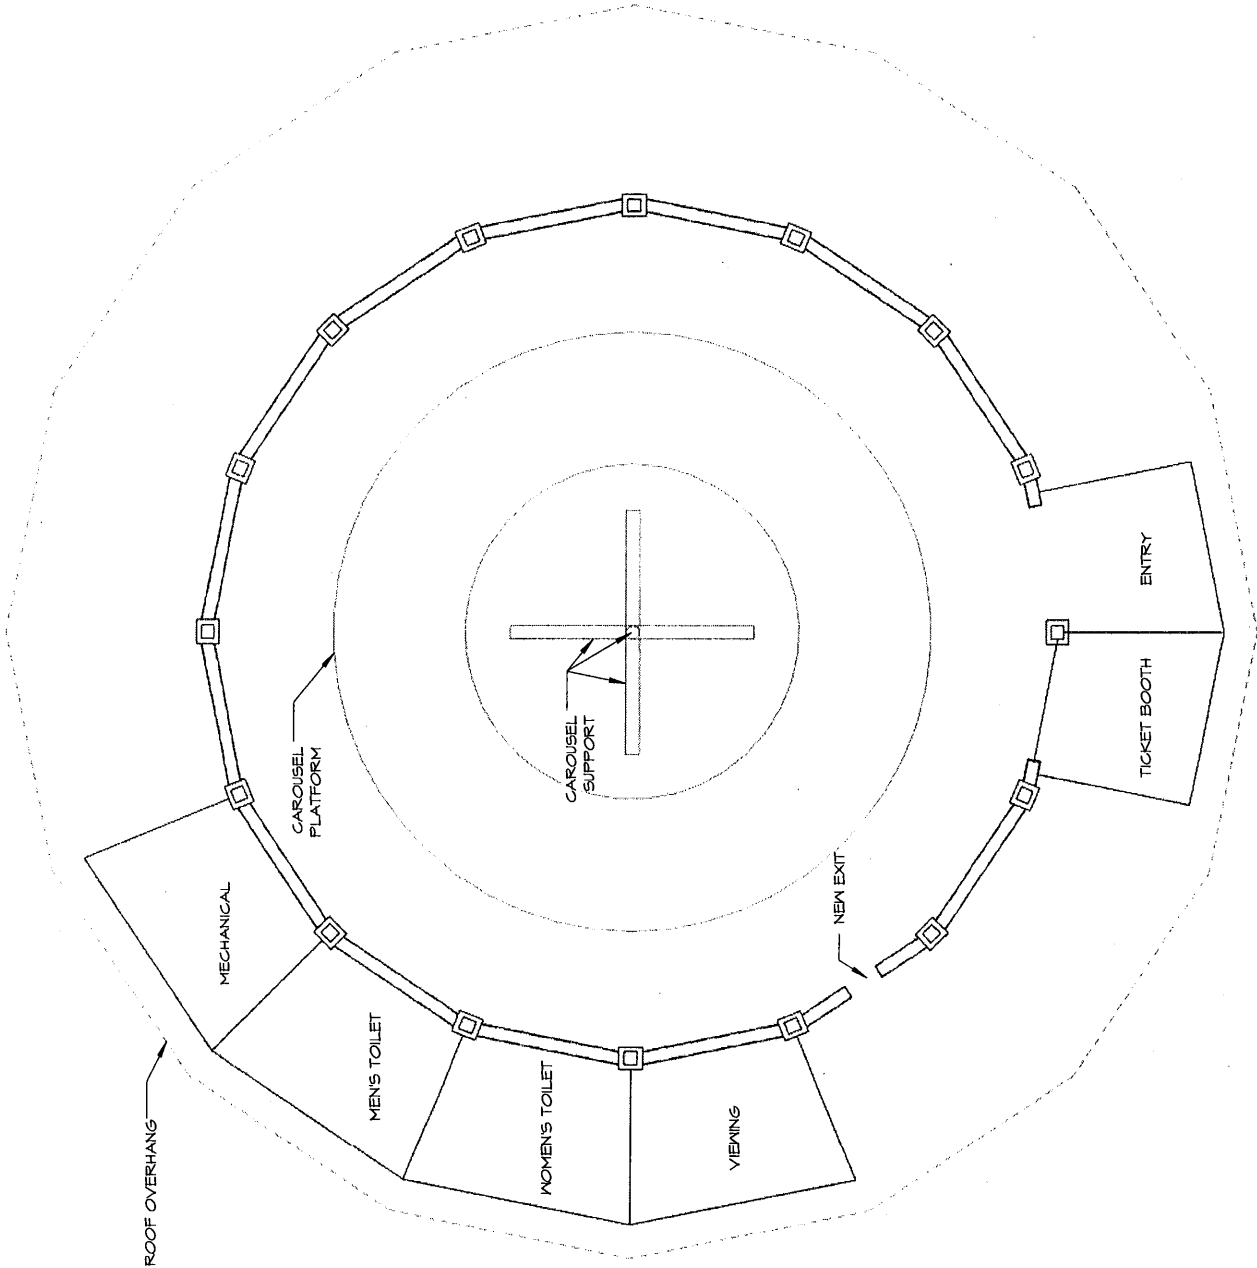
OPTION A

There are a variety of ways to approach adding square footage to the carousel house to accommodate observation space, restrooms, and a mechanical room. A partial addition could be constructed in two or more bays at the west side of the existing building by enclosing the area under the outer roof overhang (see Option A). This would provide as much as ten feet of additional perimeter to the building without a radical change in appearance from most viewing points. The small addition would be enough to provide a limited viewing area, small restrooms, and a small mechanical room. Another option (see Option B) would be to build a new exterior wall for the carousel house about halfway between the existing outer wall and the roof overhang. This enclosure would provide about five feet of additional observation and circulation space around the entire carousel. While the appearance of the house would be changed somewhat, the roof structure and overhang would remain in place.
